## **A study of the porosity of some samples of dentinal substitute material from extracted human teeth**

### **Abstract**

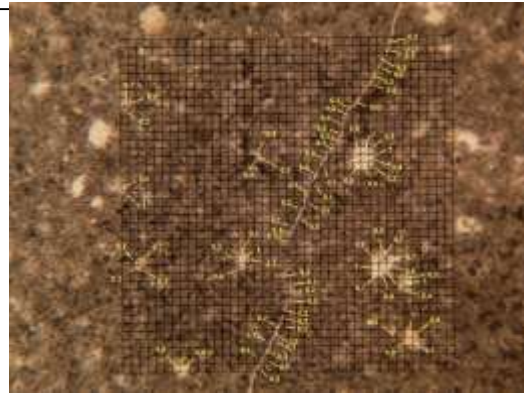
Fig. 2 a-h Microscopic photos corresponding to a first set of microscopic fields adjacent to analyzes for the first Biodentine sample. The magnification order of all images is 100x. The surfaces corresponding to the pores and cracks are marked

For each Biodentine sample porosity was determined by 6 sets of 8 adjacent microdomains (located next to each other), respectively 3 sets for each section. Finally, average values were determined for each set and for each sample. Microscopic images corresponding to a set of microdomains for the first Biodentine sample are shown in Fig. a- h.
